Remanufacturing the Lexmark E230/330/340 OPC Cartridge

OVERVIEW

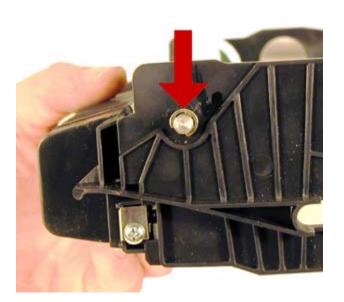
- 13) Install the drum axle from the large gear side. See Figure 13
- 14) Install the E-ring on to the axle. See Figure 14
